THE BUST OF LENIN BY MEMOS MAKRIS: FORMS OF CORROSION AND CONSERVATION WORK

D. Charalambous, A. KaramPotsos and V. Lampropoulos

T.E.I. of Athens, Dept. of Conservation of Antiquities & Works of Art,

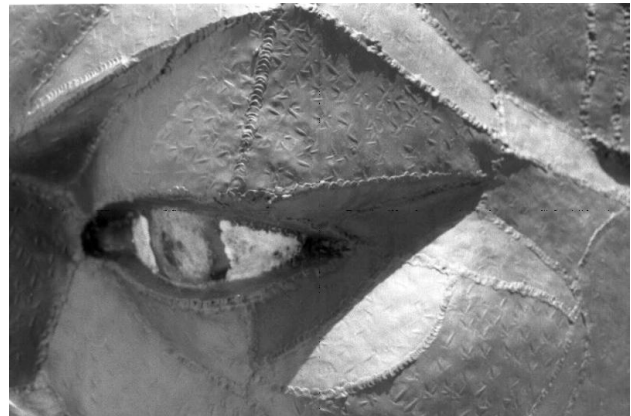
The attribution of the eyes is of great importance for the work of art. The iris is made of white, blue, red and brown murano glass. Fig. 1. The powdered glass was poured into a copper mould in the appropriate shape and heated to melting point. Then each iris was adapted to the eyes of the sculpture.

Fig. 1, The different parts are made to the appropriate shape by beating and joined together by soldering.

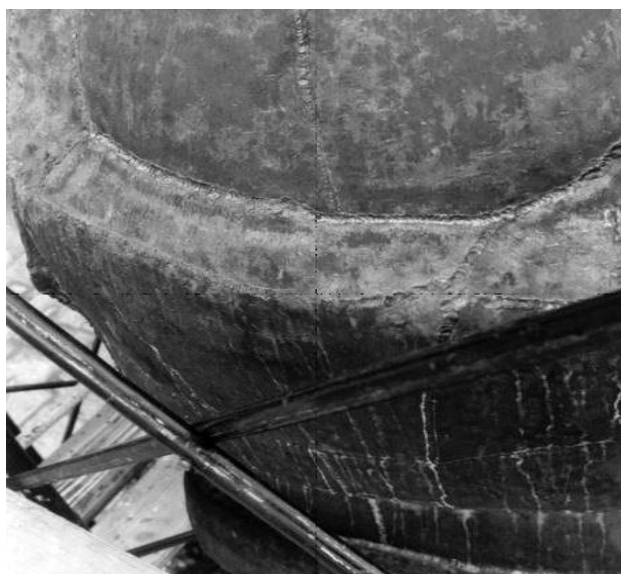
A thorough observation of the sculpture revealed the localised loss of the artificial patina, mainly on the edges and the most exposed areas. The protective coating had lost its original transparency and in specific areas has a dull to whitish appearance (Fig. 4). Where the surface is protected from rainfall, it is coloured dark brown Fig. 5.

The alteration of the visual and mechanical properties of the organic coating is probably due to deterioration processes caused by the effects of oxygen/ozone, moisture, ultraviolet light and air pollutants. The main cause of the whitish appearance is the adsorption of aerosol particles from the polluted environment. In the dark brown areas, particulate matter has accumulated (e.g. soot, soil material), which is not washed away from the surface by rainwater. Besides the important aesthetic problems this causes, the degradation of the coating can dramatically increase the corrosion rate of the underlying metal.

Fig. 4: Dull / whitish appearance.

- The removal of the old coating with a soft cloth impregnated with a mixture of organic solvents (ethanol, acetone and white spirit), a time consuming treatment due to the insolubility of the deteriorated wax.

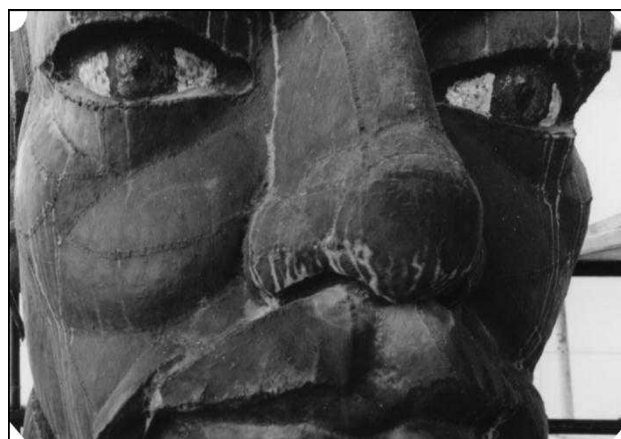
Fig. 5: Dark crusts on areas protected from rainfall.

- The application of sepiolite poultices with deionized water and the chelating agent E.D.T.A. removed the dark brown crusts. This time consuming procedure was carried out repeatedly and locally on the crusts, with special attention given to avoid contacting the metal with the poultice. The areas were pre-wetted and the poultice was applied and left to dry for about one hour. The repeated application of the poultices led to the collapse of the crusts, which were finally removed with the use of a scalpel. After treatment, the area was thoroughly washed with deionized water, as any residues could cause salt crystallization problems.

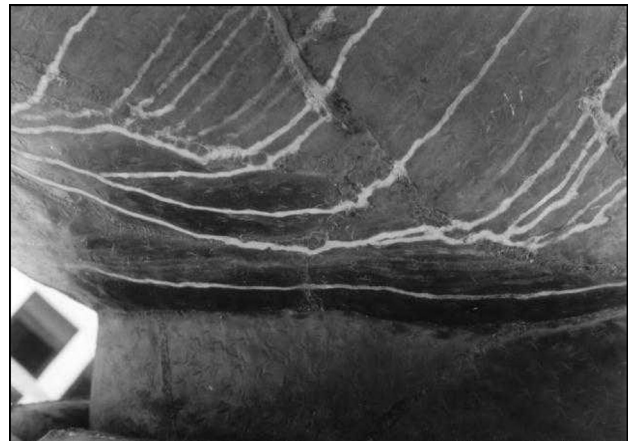
The most evident symptom of time on the sculpture is the presence of whitish “streaking”, mainly on areas that are not directly exposed to rainfall, but also in places washed by rain, such as the eyelids, the neck and the lowest part of the nose. This streaking consist of a rather hard whitish or grey substance, with a slight green hue. During the cleaning of this substance it was found that no protective coating or artificial patina was left underneath the streaking, and a bright copper surface was revealed.

potassium were also present. Iron and zinc were detected in small quantities. According to the analytical data and relevant references in the literature, the streaking material probably consists of salts that originate from various particles (e.g. soil material). The streak begins in places where a preferential condensation of water vapour occurs when ambient temperature reaches the dew point. In these water droplets acid pollutants, suspended particles and other corrosive materials are accumulated. All these materials can contribute to the attack on the artificial or natural patina or even the underlying copper metal through two main processes:

- Direct contact of corrosive substances present in the various deposits (e.g. sulfur oxides, organic acids).
- Withholding humidity on these specific areas of the sculpture.

These corrosive effects are responsible for the etching of the copper along the streaking. The detection of copper in the streaking material probably originate from copper corrosion products, which also give the observed characteristic green tint.

fig. 6: "Streaking" on the surface of the monument.

- Repatination of the bright areas of copper which had necessarily been revealed during cleaning (e.g. along the streakings) with the application of a 5% w/v potassium sulphide solution in deionized water, after pre-heating and using reducing flame afterwards.

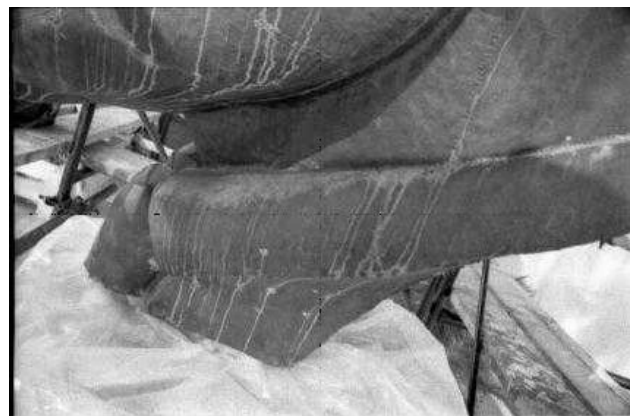
Fig. 7: "streaking" on sculpture.

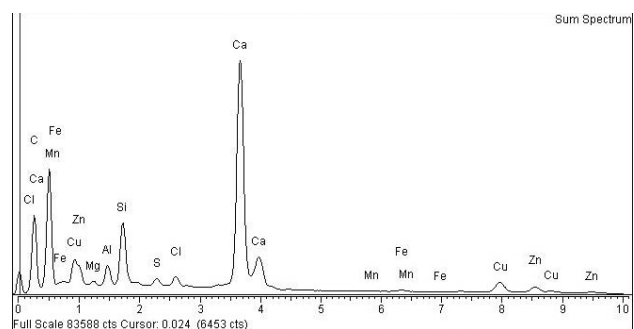
In order to determine the composition and origin of this substance, a sample taken from the streaking was examined under a scanning electron microscope equipped with an energy dispersive X- ray analysis system (S.E.M./ E.D.X.A.).

The analysis of the substance, showed that calcium-containing material, probably of atmospheric origin, predominates within the makeup of the crust. Considerable amounts of silicon, copper, magnesium, aluminum and

Fig. 8: EPMA analysis from the "streaking" shows the presence of suspended particles (calcium, aluminium and silicon compounds) with some corrosion products of the metal.

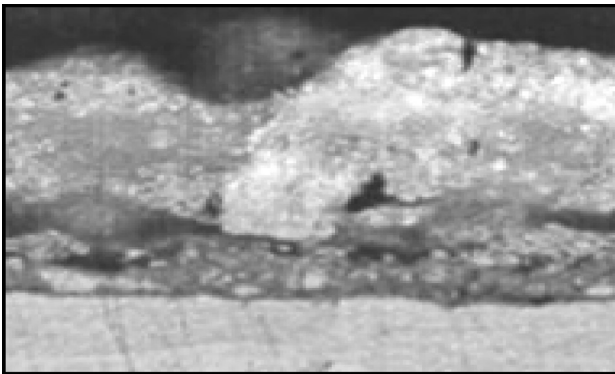
As shown in Fig. 9, copper is covered by a continuous thin layer of cuprite (Cu_2O), followed by a thick green layer of paratacamite ($\text{Cu}(\text{OH})_3\text{Cl}$). The local formation of paratacamite on the surface can be explained by the attack of chlorides on areas where the coating had been removed or was loosely adhered

In the samples examined, there is no evidence of pitting beneath the layer of cuprite. However, the formation of paratacamite instead of other corrosion products usual on outdoor copper sculptures (e.g. copper sulphates) indicates the high concentration of chlorides in the surrounding environment, probably from the sea. The potential for a more severe attack in the future should be given serious consideration, as shown in previous work done by Organ (1970), Sharkey *et al* (1971) and Elwyn *et al* (1996).

Fig. 9: Photomicrograph of the corrosion products, showing the successive layers of cuprite and paratacamite. A thin cuprite layer in contact with copper and a thicker paratacamite layer on top.

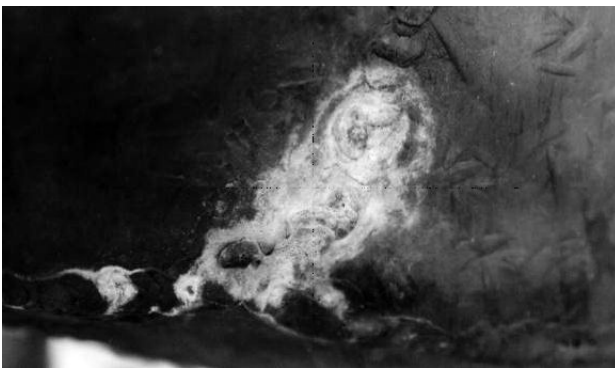
Layers of green copper corrosion products were observed on specific areas of the sculpture, especially around the brazed joints. From a well protected point on the neck of the sculpture we were able to take a sample of the corrosion products which was then observed under an optical microscope. The different corrosion products were identified by x ray diffraction carried out at the Demokritos laboratories.

Fig. 10: Layer of green corrosion products.

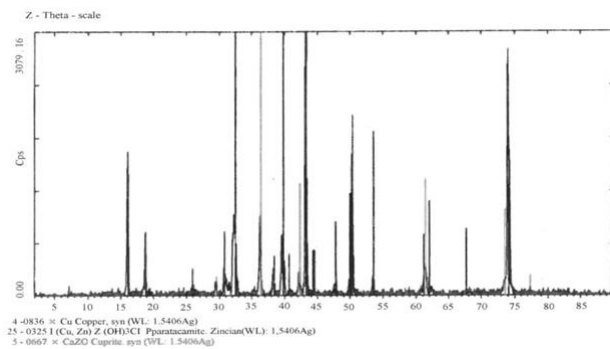
Fig. 11: Results of analysis by XRD from the points of fig 9, 10.

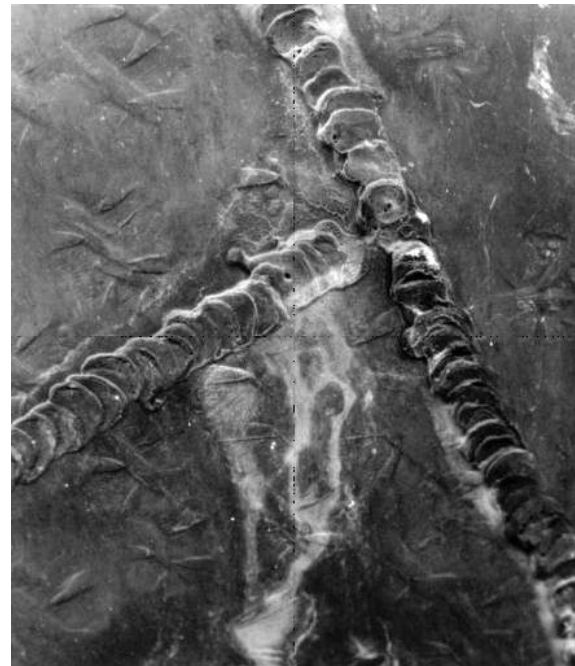
Powdery orange-brown layers were observed around the joints of copper sheet and the steel armature. They probably consist of iron hydroxyoxides ($\text{Fe}_2\text{O}_3 \cdot \text{H}_2\text{O}$, $\text{FeO}(\text{OH})$) released through the cracks of the brazed joints. The direct contact between iron and copper probably leads to the galvanic corrosion of the steel beams (Fig. 12).

Fig. 12: Example of galvanic corrosion on welds.

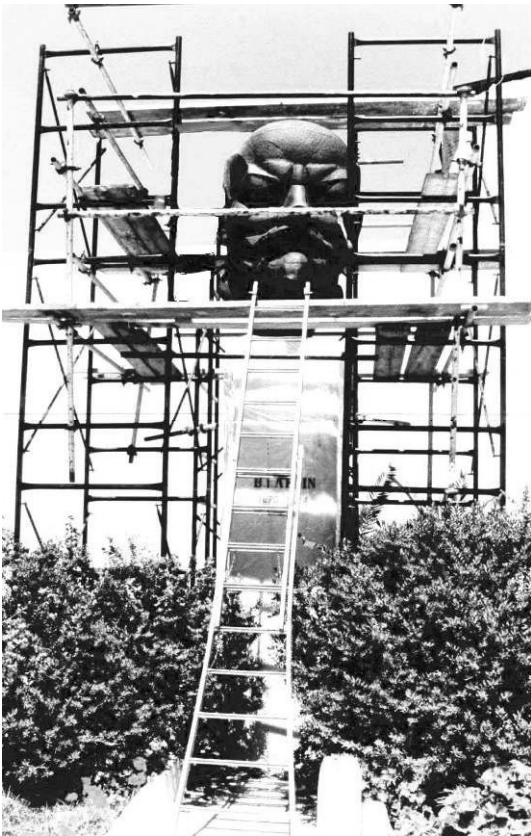
Fig. 13. The monument with the scaffolding placed for the implementation of the conservation work.

For the implementation of the conservation work, scaffolding was placed around the monument Fig. 13.

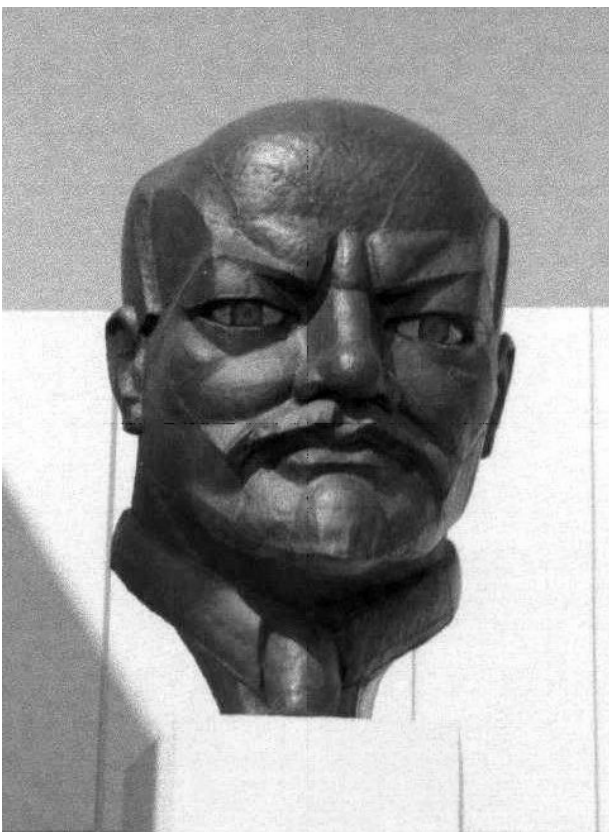
Fig. 14: Front view after conservation.

For the protection of the monument against the rough outdoor environment, microcrystalline synthetic wax applied by heating the external metal surface to around 100 °C. The wax coating also toned down the variations in colour, and gave the surface a darker appearance than before, as was the artist's original intention. After the application by brush, a thin cohesive film is created, which is impermeable to water and resistant against acidic, alkaline or other corrosive substances. It is stable in temperatures up to 90°C and can easily be removed using the appropriate organic solvents.

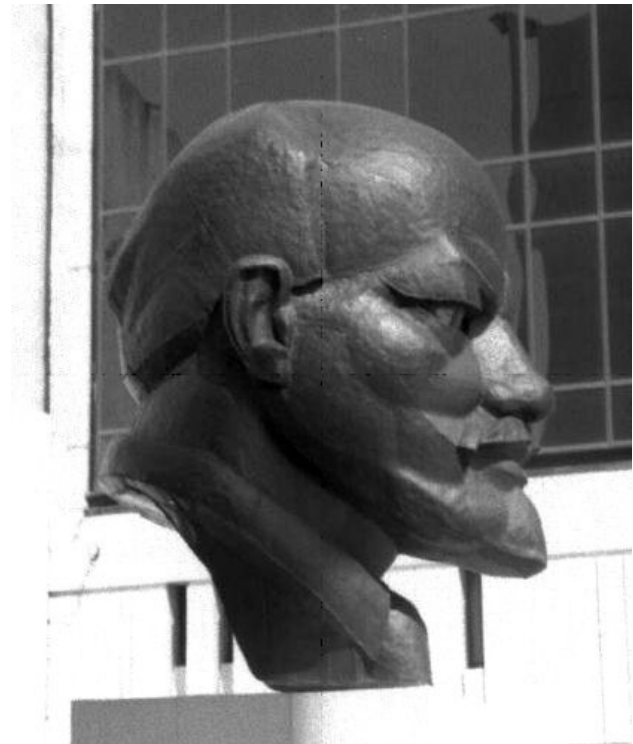
Fig. 15: Side view after conservation.
