EURO CARE EUROMARBLE

October 21-23, 1996, Patras - Greece

CONSERVATION OF THE STATUE OF CHARILAOS TRIKOUPIS IN STADIOU STREET

TECHNICAL REPORT

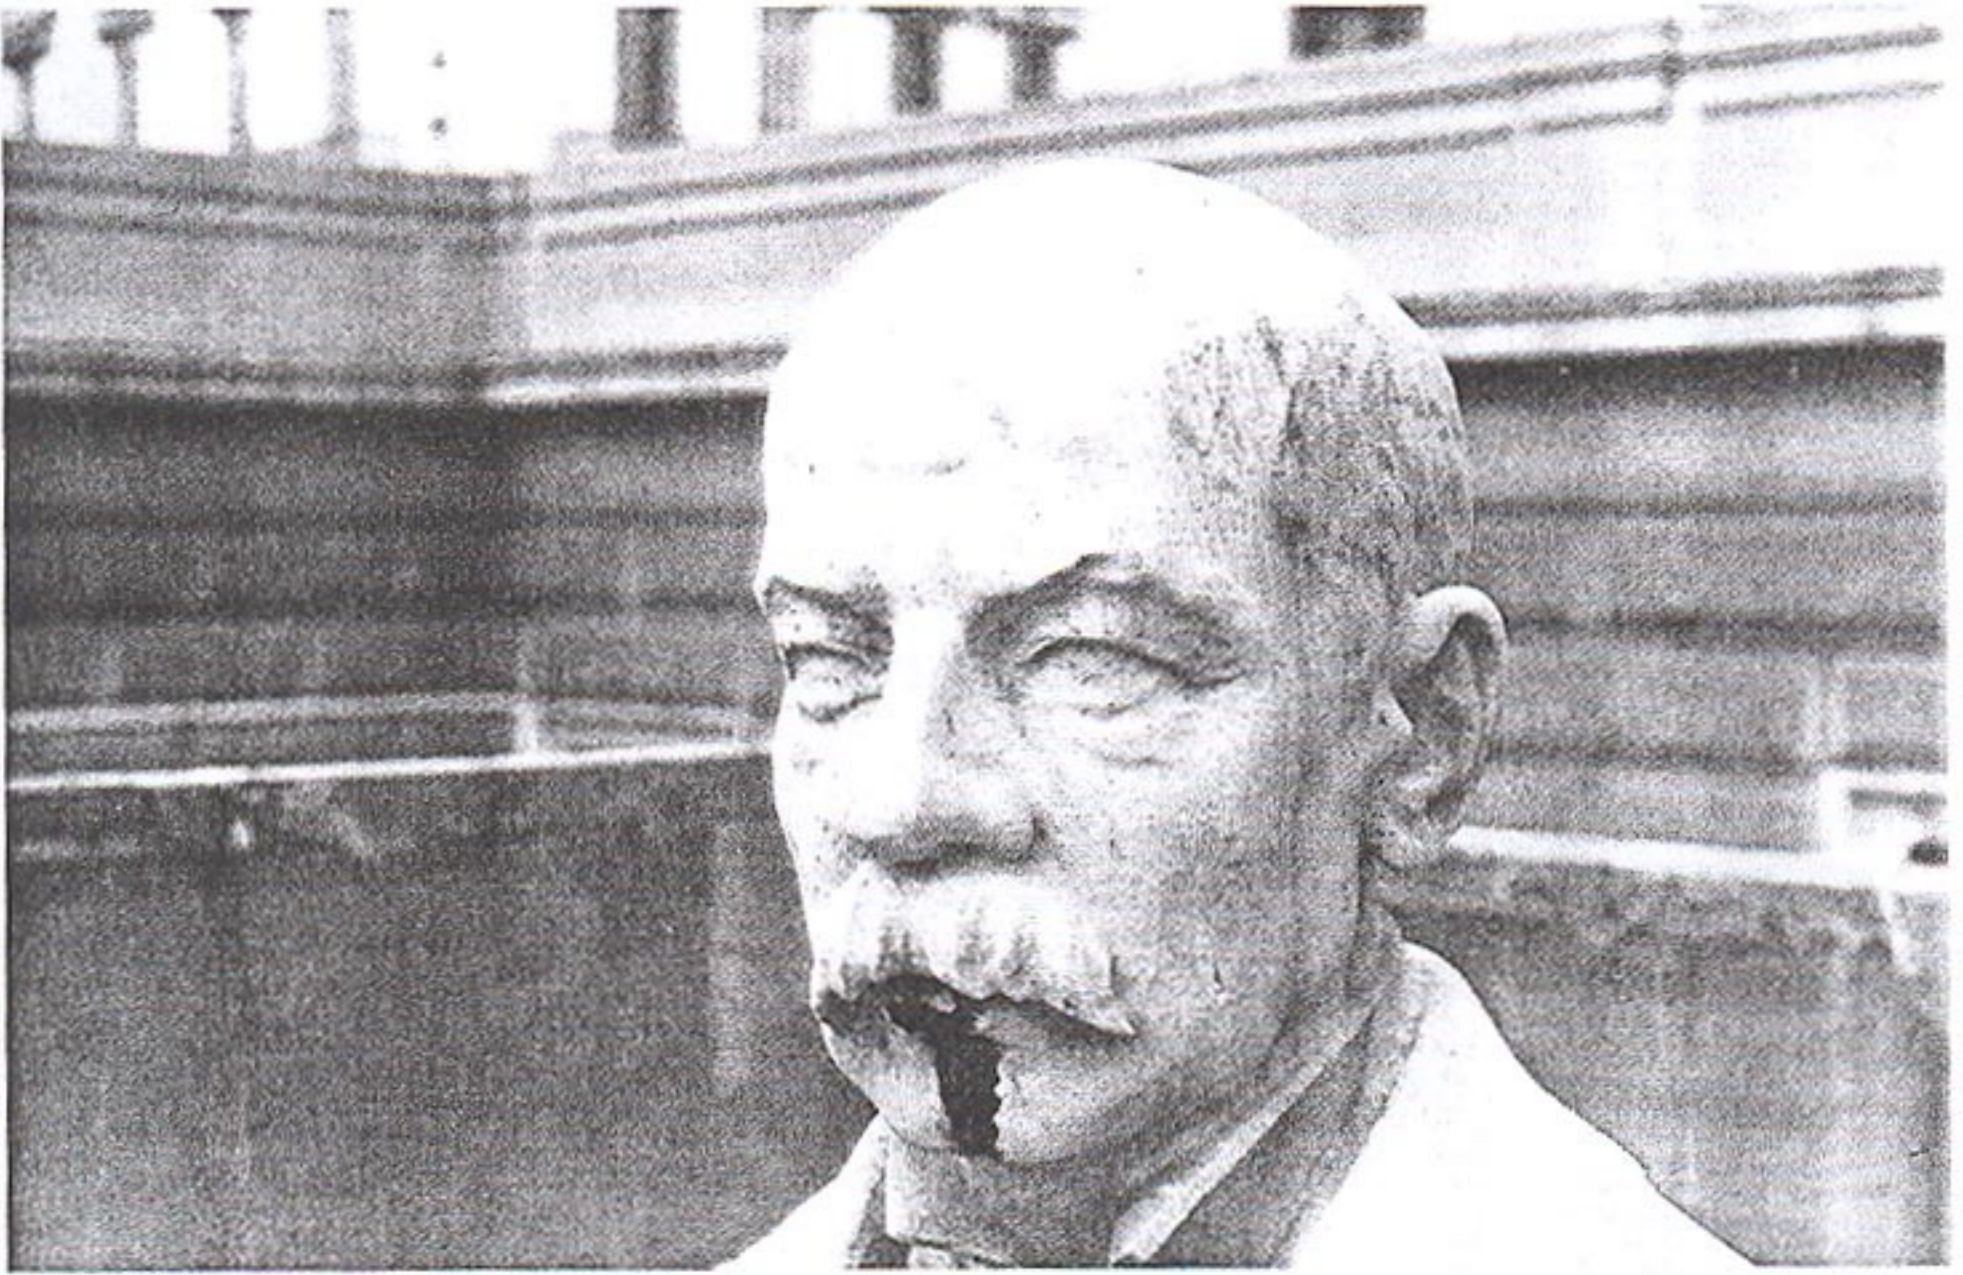
- a. Granular disaggregation of the surface, in relatively large extension/scale, due to the action of the atmospheric carbon dioxide, in correlation with the moisture.
- b. Black, hard crust, mainly into the cavities of the sculpture details of the monument, as a result of the interaction between the rainwater and the deposit of mineral particles and/or atmospheric pollutants.

2. Black crust on the face of the statue.

The cleaning of the black crust was a rather laborious,time consuming work, and it was realised by application of pastes made by absorbent clays (sepiolite) mixed with deionised water. In areas where it was not detected formation of gypsum, sodium bicarbonate and ammonium bicarbonate were added to the above pastes in order to

create an alkaline environment that favour the dissolution of the deposits. There was also added complex agents of calcium ions (EDTA). In cases where the crust were thick and hard, and the cleaning with pastes didn't work, mechanical cleaning under the microscope with a lancet was considered as the most suitable way of cleaning.

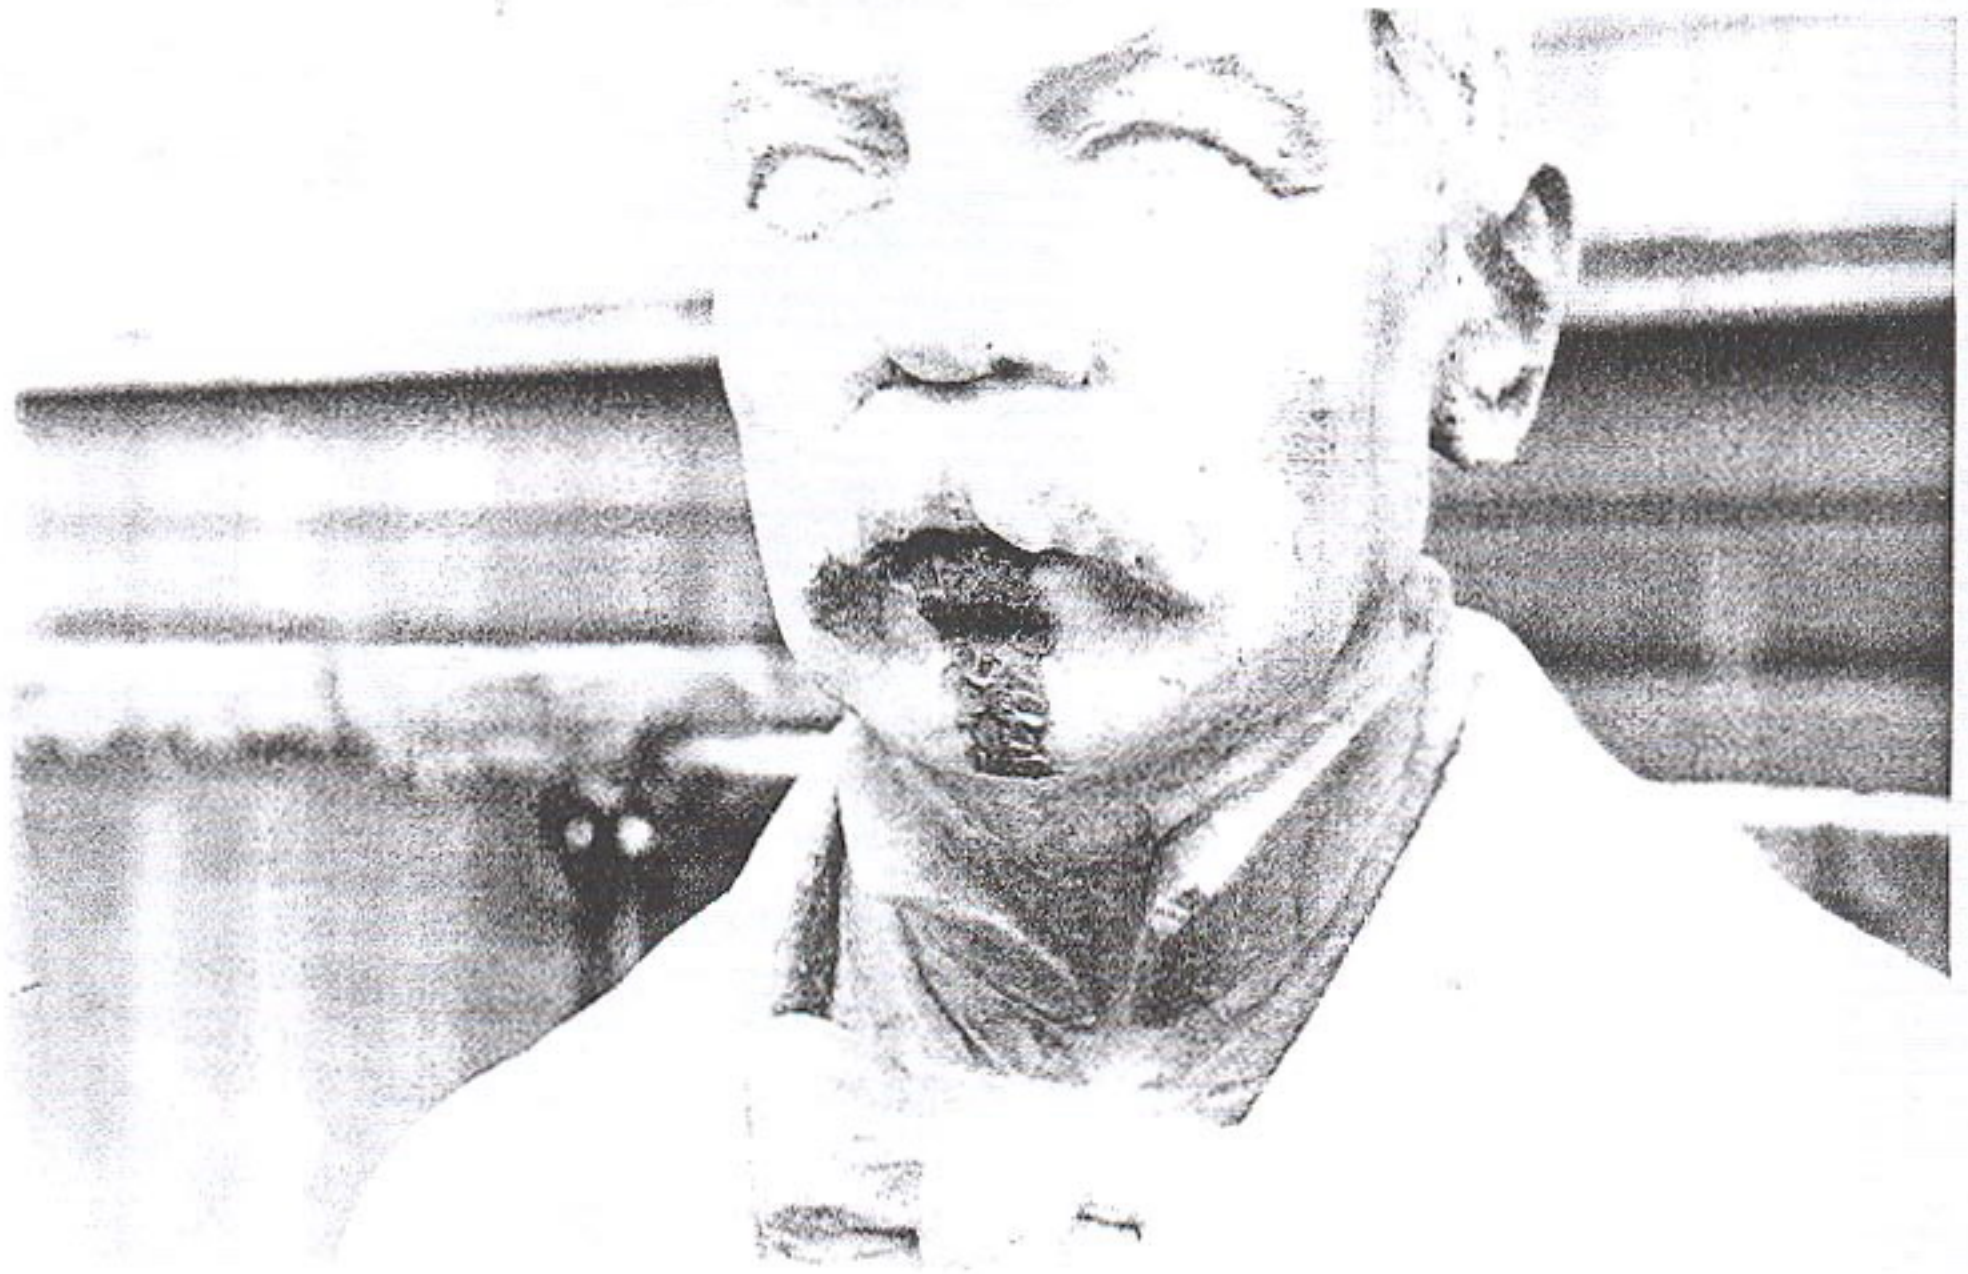
3. Cleaning of the crust.

The above mentioned pastes were applied on the sculpture ornaments from the top to the bottom, and they were covered with a thin plastic sheet in order to prevent the evaporation of the deionized water or of the solution. When all the pastes were removed, the area was thoroughly cleaned by rubbing off the surface with soft brushes and then by successive rinses with dilute ammonia solution and deionized water. After each rinse the collected solution was subjected to pH and electrical conductivity measurements in order to verify the total removal of acidic or alkaline deposits and soluble salts from the marble and the mortar surface. In many cases the application of the pastes was repeated more than once while the duration of the treatment didn't exceed the 60 minute. In the deepest recesses of the sculpture and in the details where the crust was thick and hard, the marble underneath was in an extremely bad condition, very weak and porous. Problems of fragility and of high porosity were also detected in other areas of the marble surface.

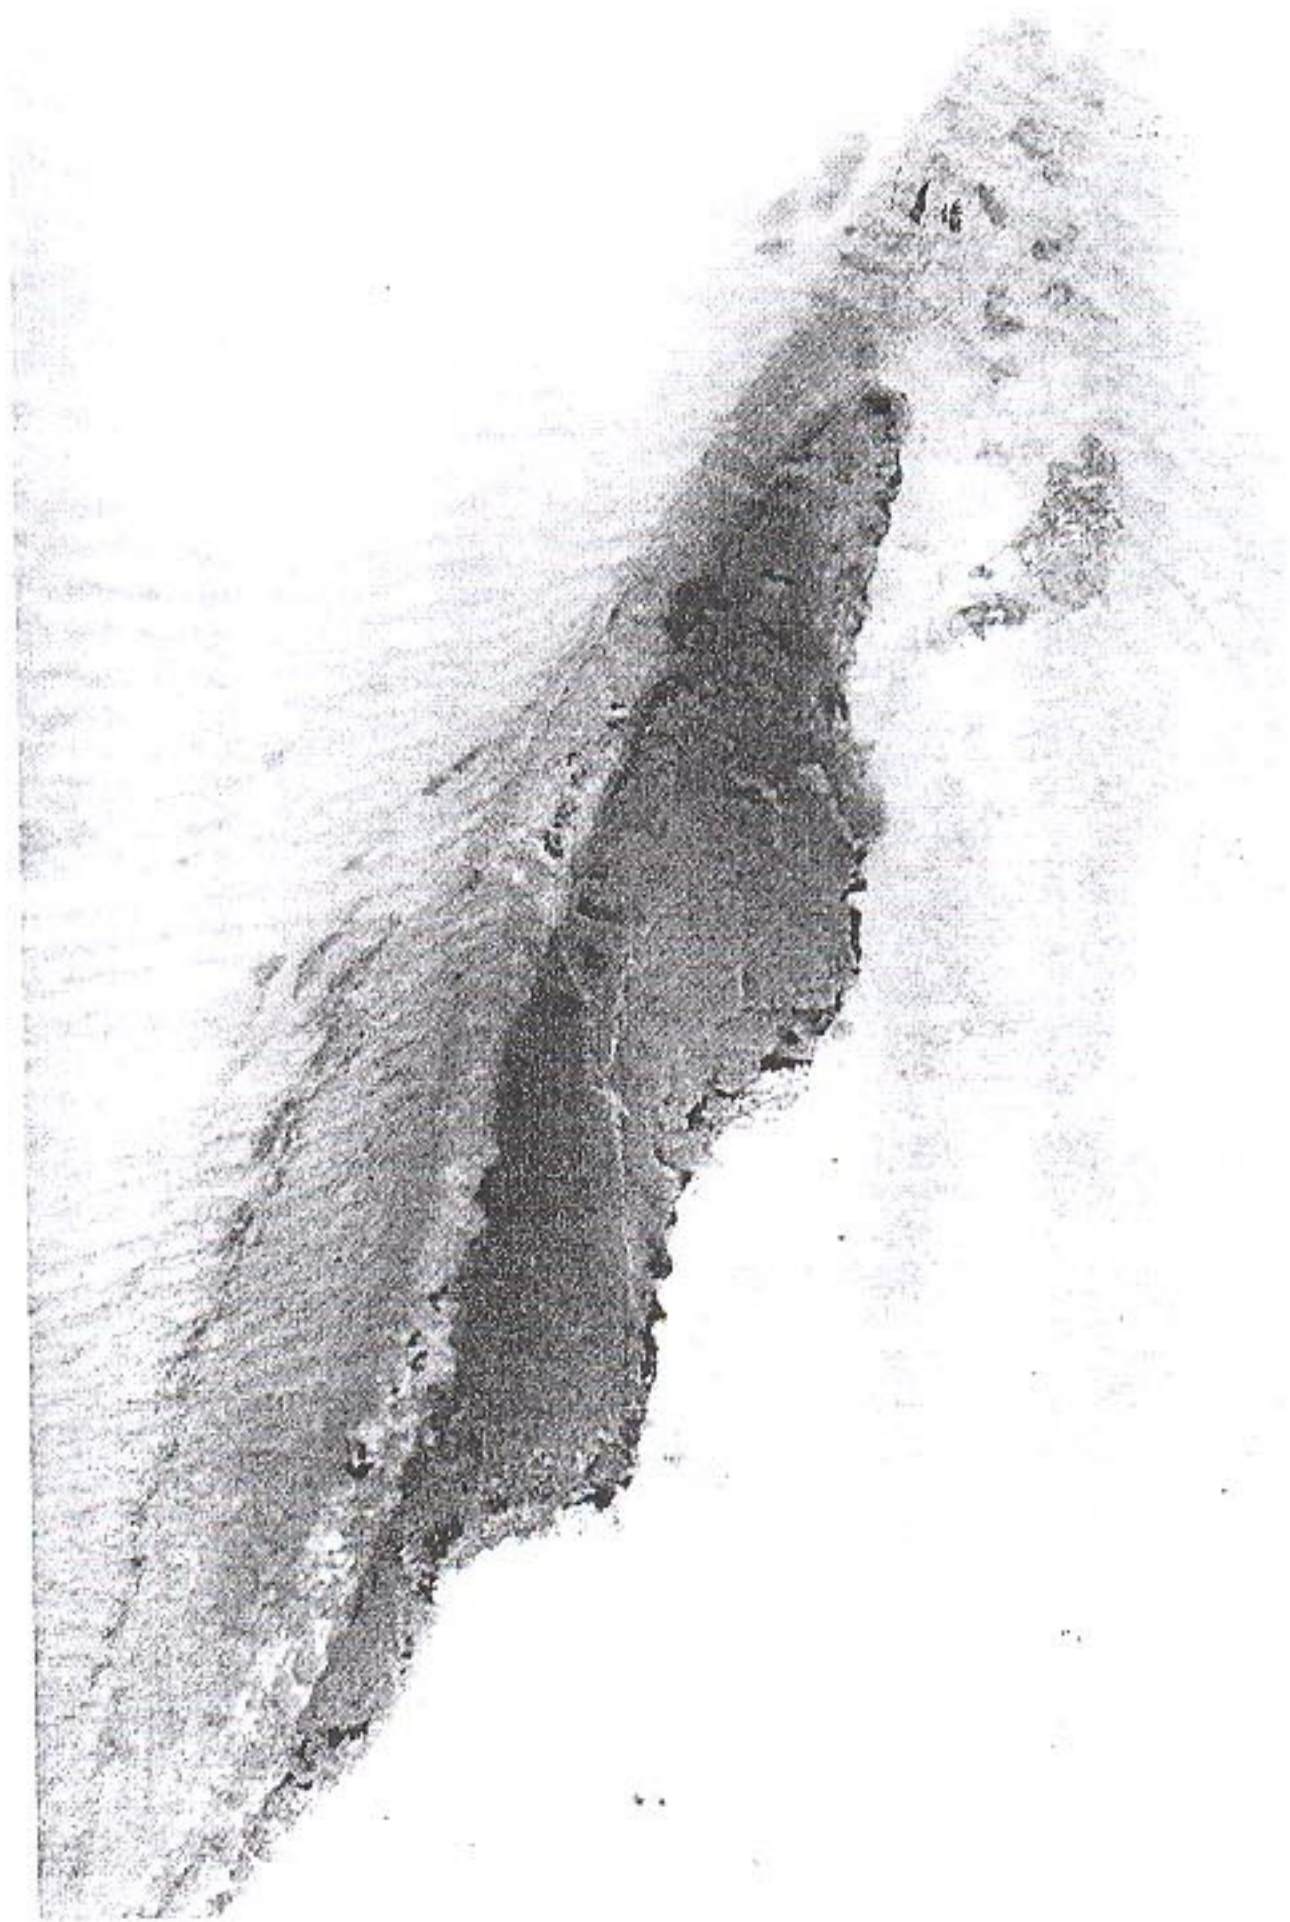
6. Crust cleaning process.

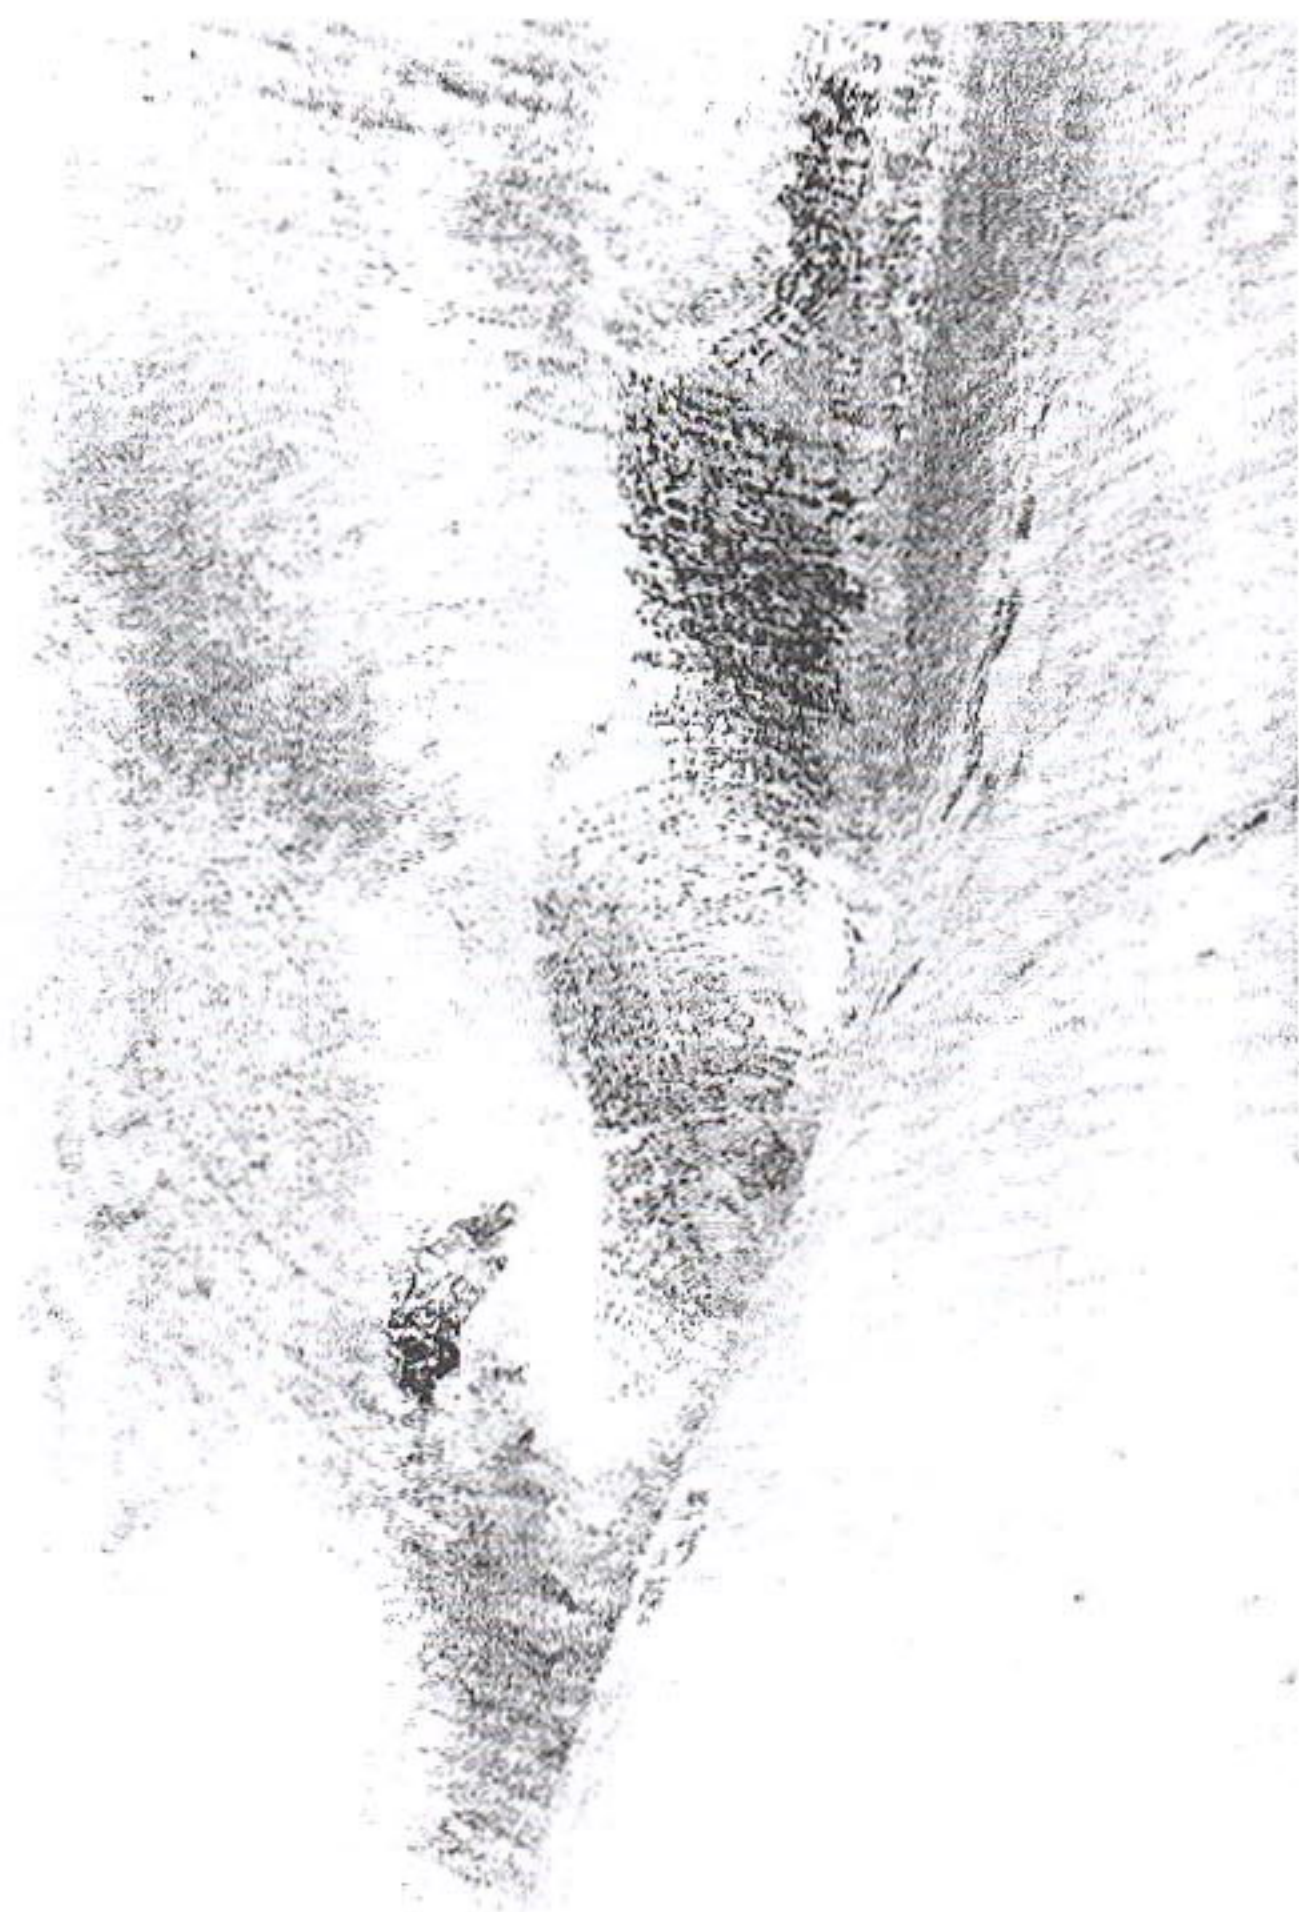
7. Part of the sculpture after cleaning using sepiolite paste.

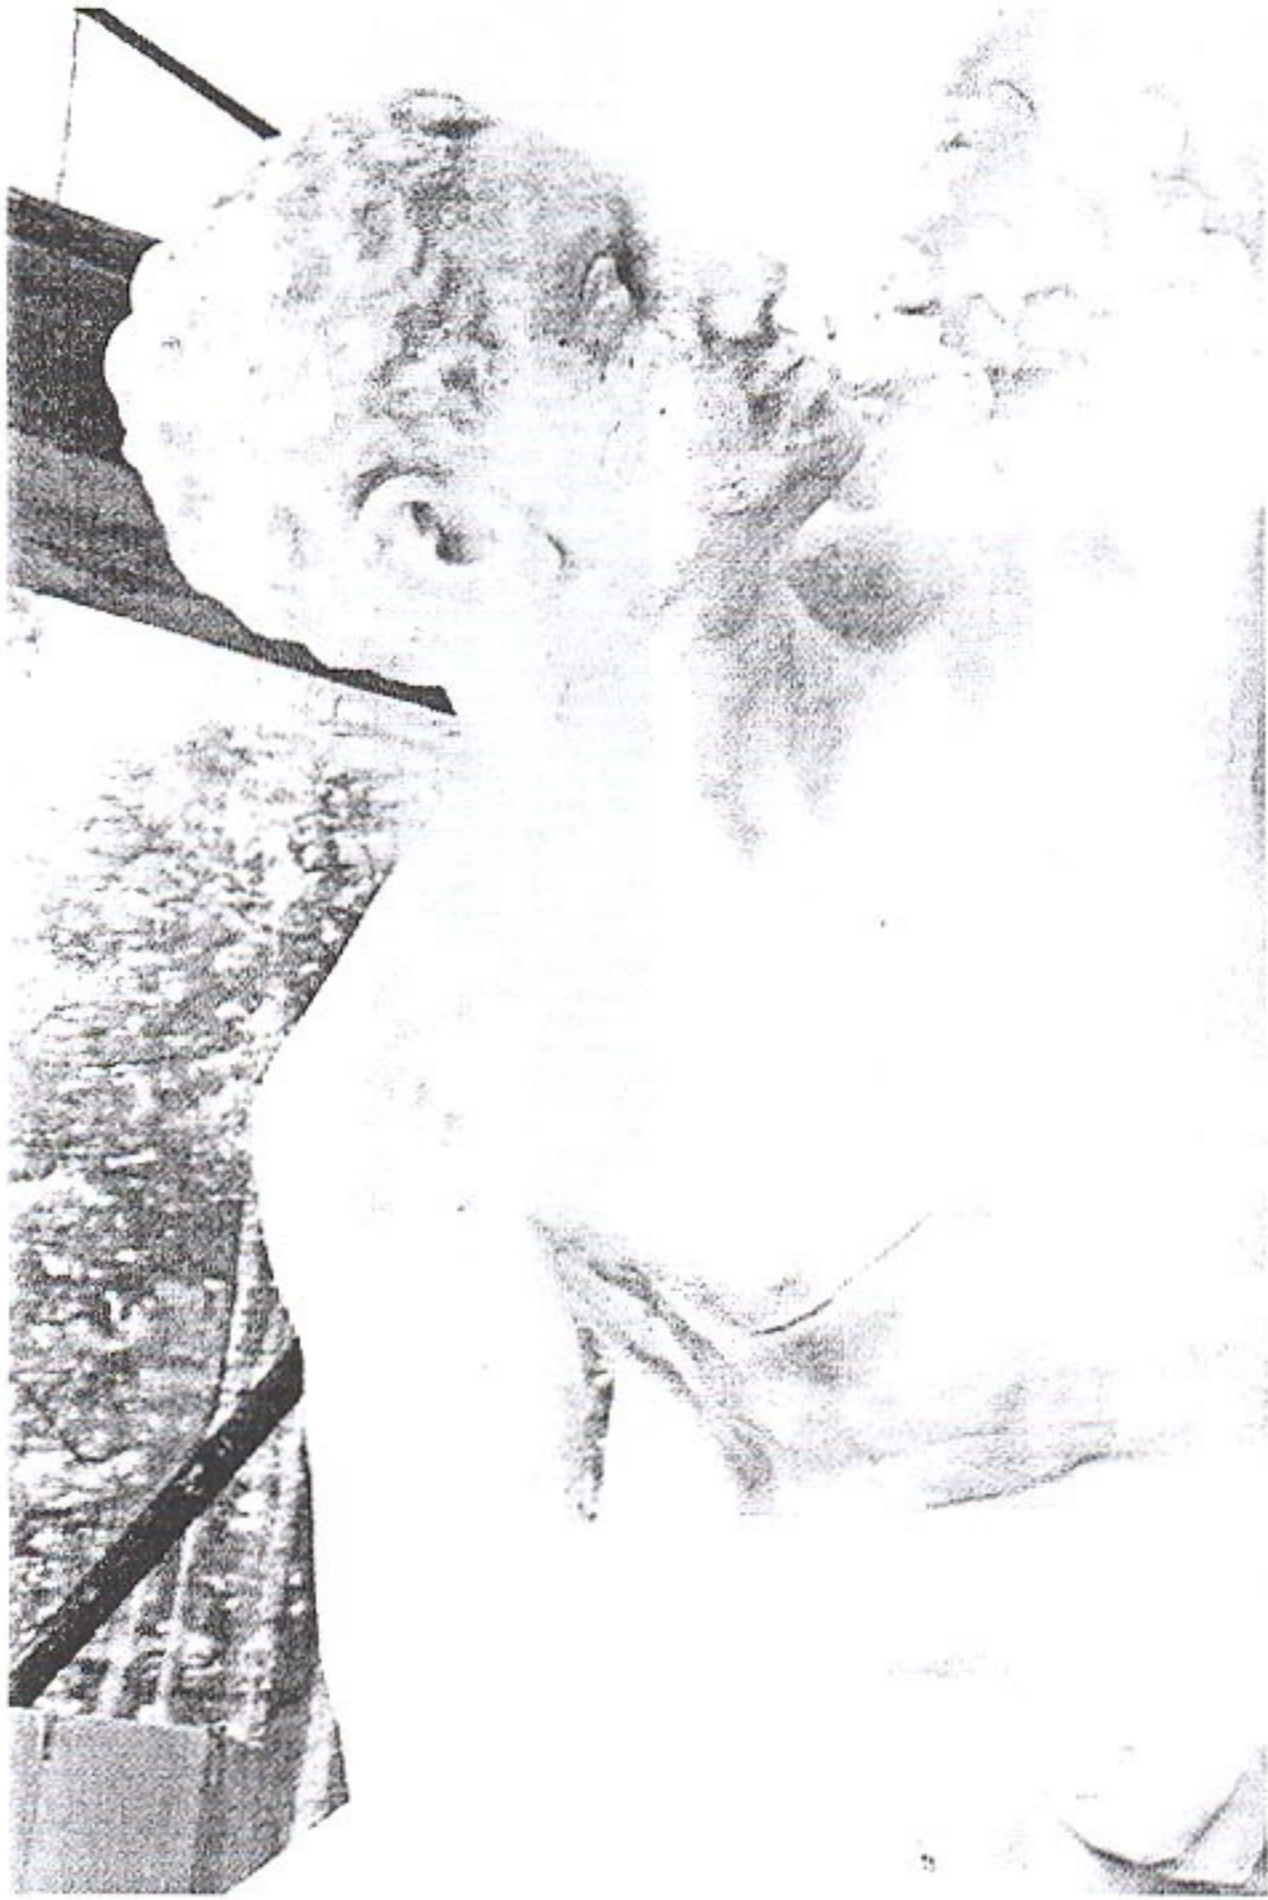
9. *The angel after cleaning.*

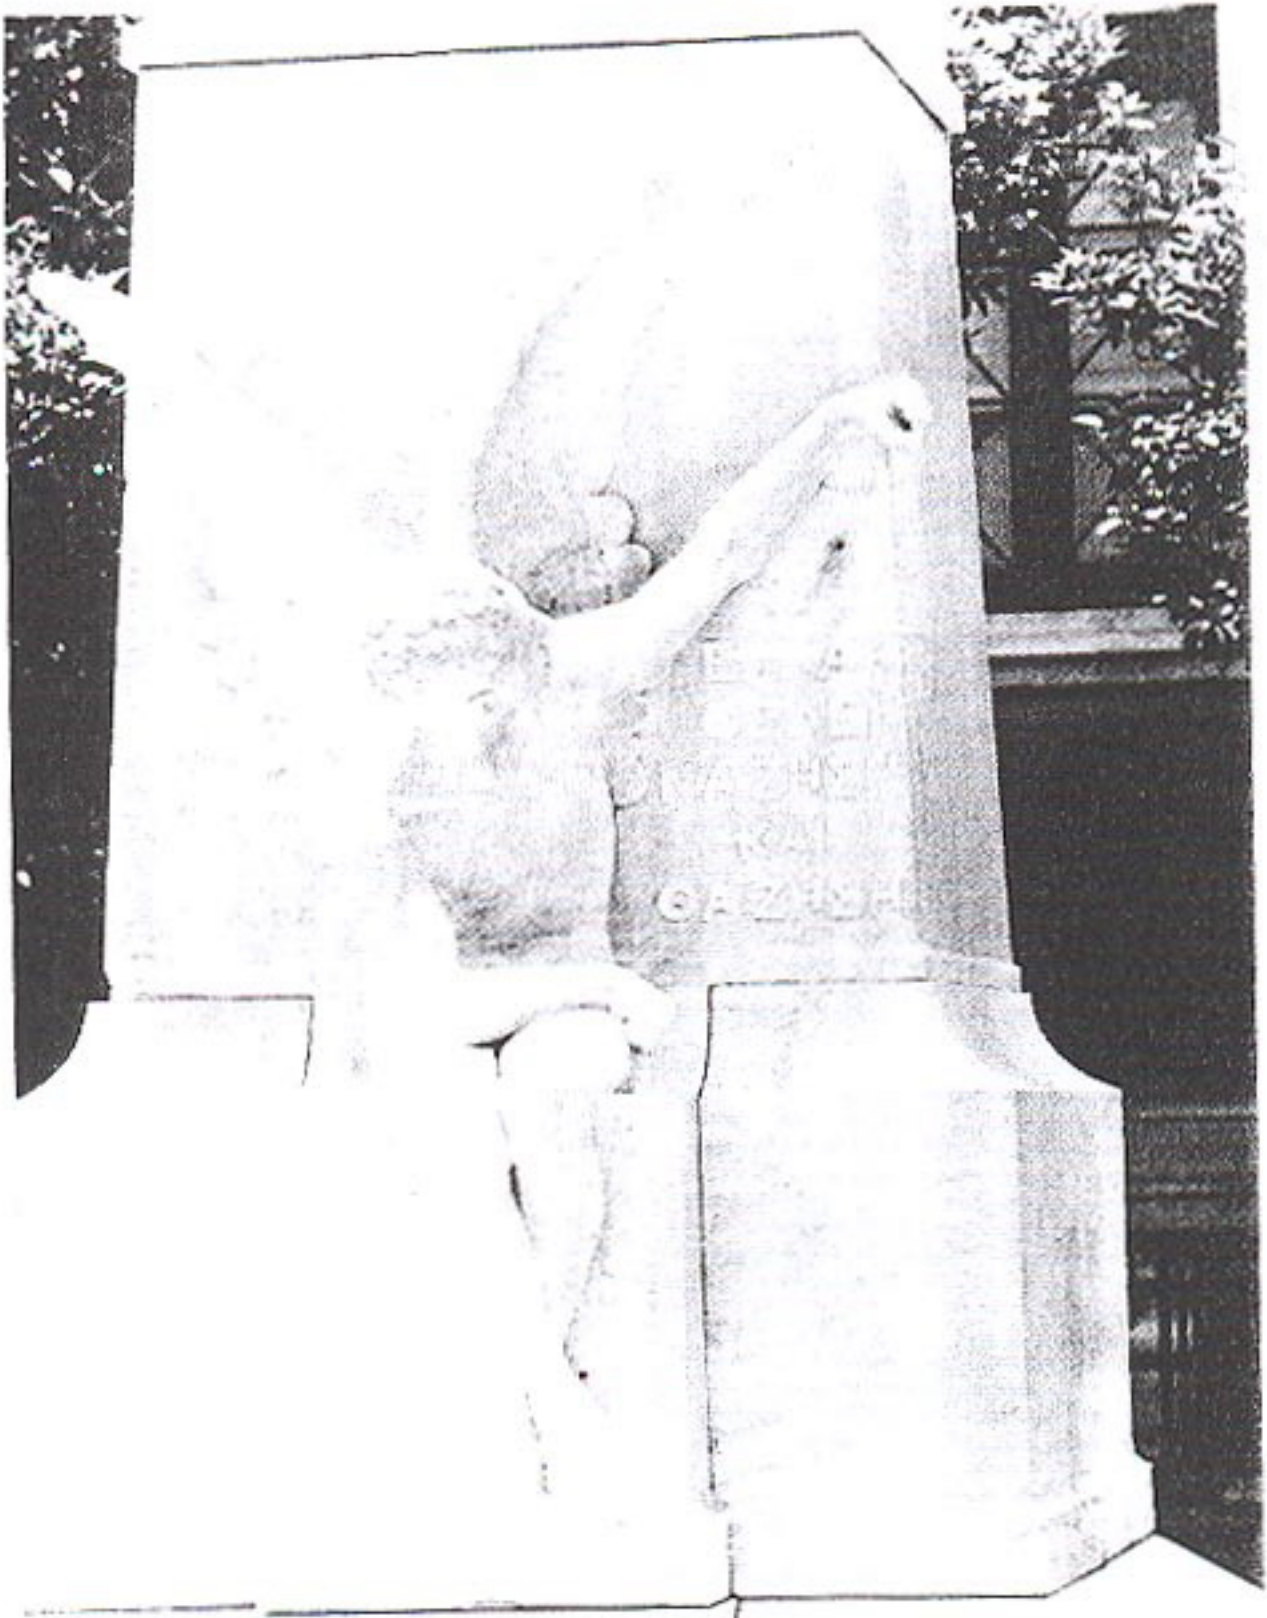
10. *The statue after conservation.*
