9th
INTERNATIONAL CONGRESS
ON DETERIORATION
AND CONSERVATION OF STONE

**9th INTERNATIONAL CONGRESS
ON DETERIORATION AND
CONSERVATION OF STONE**

A COMPARATIVE STUDY OF MORTARS CONTAINING BARIUM HYDROXIDE ($\text{Ba}(\text{OH})_2$). APPLICATION ON MONUMENT'S CONSERVATION

Abstract

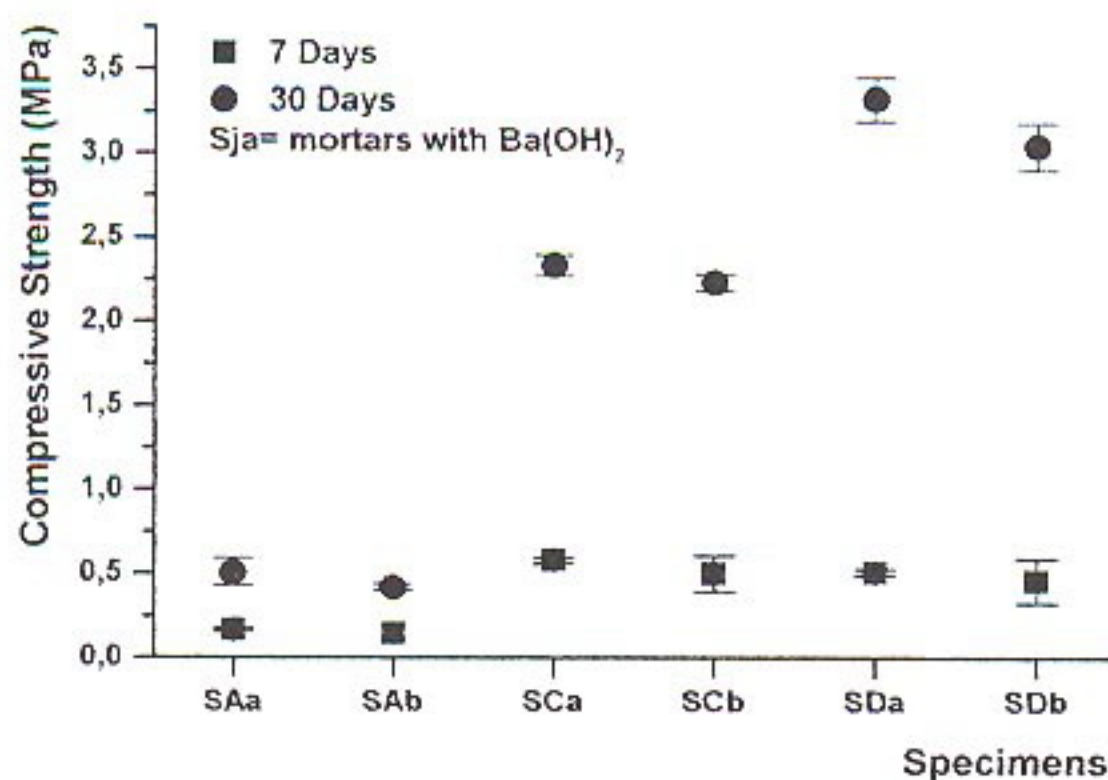
Figure 2: The variation of the compressive strength values during the setting of the specimens.

The compressive strength results show that there is no big difference between the durability of the mortars containing barium hydroxide and those that do not. Furthermore, these results are very close to the ones referred in the bibliography (Peroni, 1981).

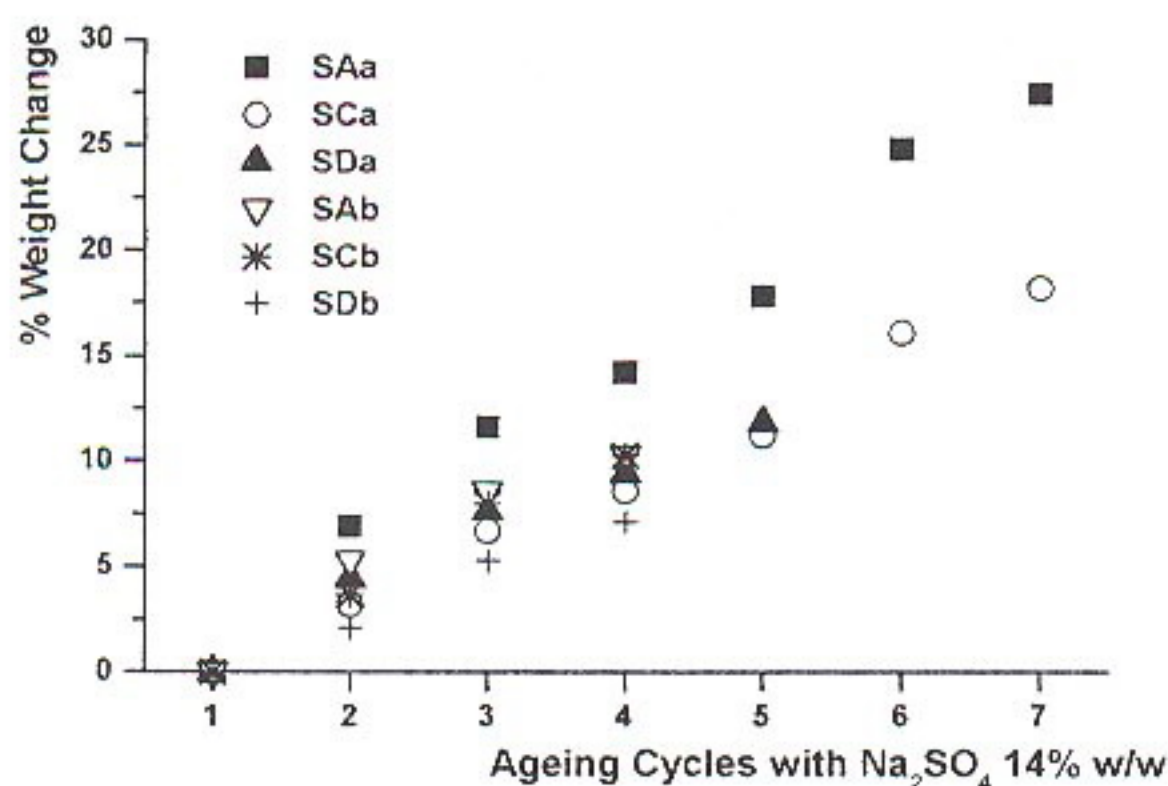
Figure 3: The %weight change of mortars specimens during the ageing cycles with Na_2SO_4 .

The results that derive from the completion of the accelerated ageing cycles with soluble salts and acid solutions are presented on figures 3 and 4 (fig. 3) (fig. 4).

The results after the soluble salts cycles show that the specimens containing barium hydroxide are more durable than their corresponding ones, they had held out for three more cycles and their appearance was better. In both series of mortars, with and without barium hydroxide, an increase of their weight of about 15% was observed due to the penetration

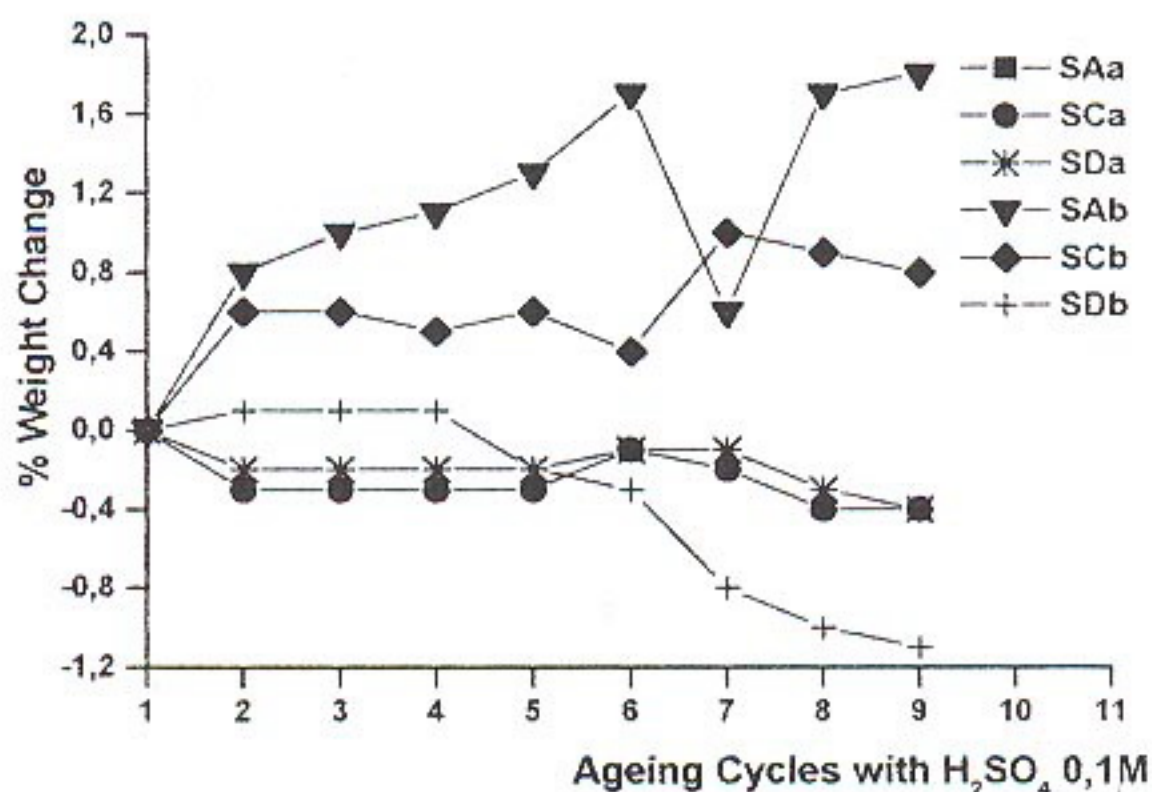
Figure 4: The %weight change of mortars specimens during the ageing cycles with H_2SO_4 .

As regards the ageing cycles with the acid solutions, the mortars that contained barium hydroxide showed greater durability than the ones without barium hydroxide, concerning mostly their appearance, volume change and loss of material. At the end of the cycles the porosity of the specimens had increased and the bonding material had deteriorated under the influence of the acid solution (fig. 6). The increase of the specimens' weight mainly at the beginning of the experiments is due to the formation of sulfuric and nitric salts as a result of the reactions between the acid and the components of the mortars. The formation of these compounds was anticipated and their presence was verified by infrared spectroscopy (FTIR) and X-ray diffraction (X-RD) analysis.

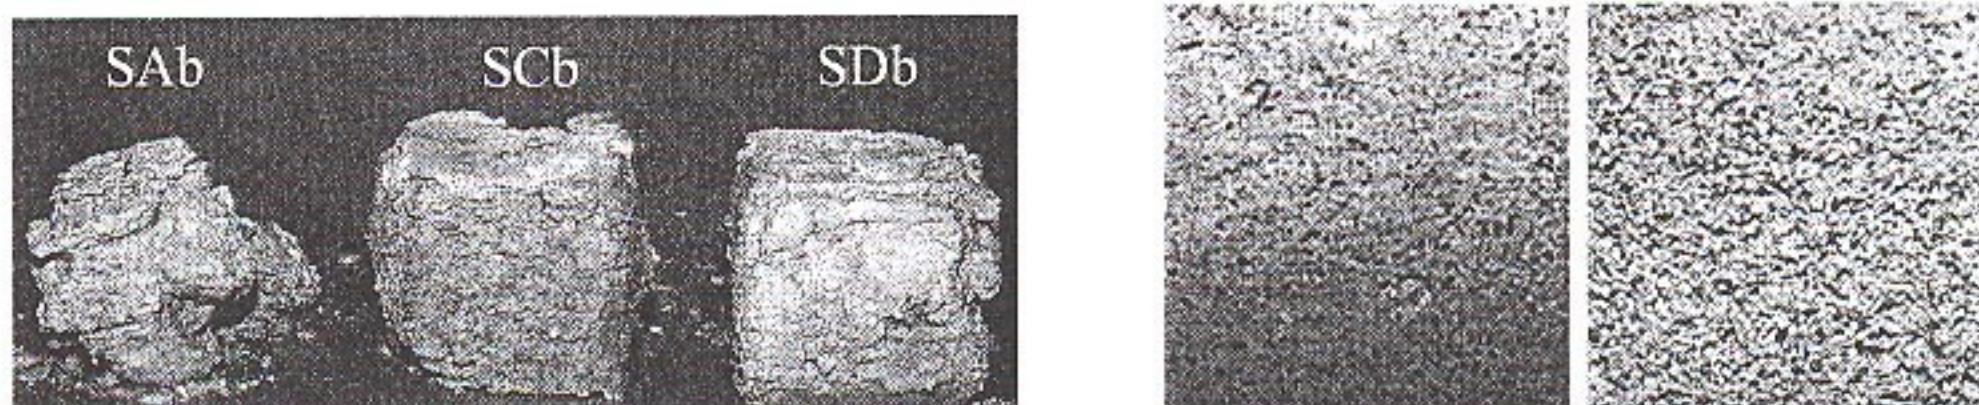
Figures 5,6: The specimens after the ageing cycles with Na_2SO_4 and the surface of SDa (left) and SDb (right) after the ageing cycles with H_2SO_4 .

and crystallization of the soluble salts into the pores of the specimens. The ageing cycles with the soluble salts have caused exfoliations, blistering and efflorescence on the surface and the body of the specimens before their total destruction (fig.5).

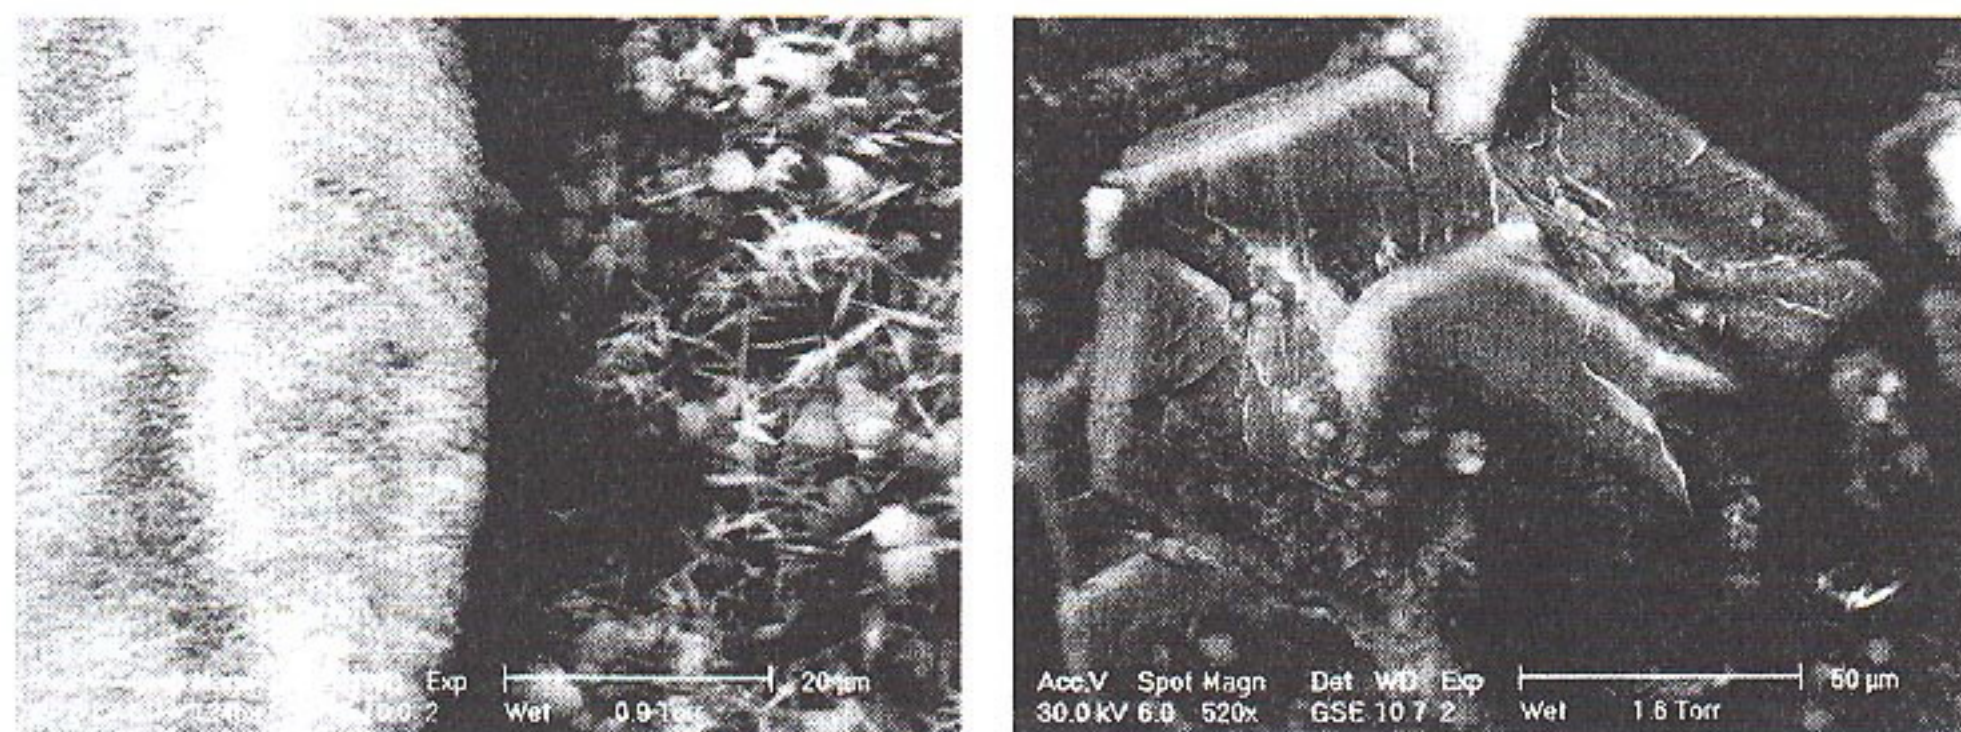
Figures 7,8: Left figure shows the distribution of barium ions (probably BaCO_3) and cement fibers. The right figure shows a crystal of BaSO_4 .

The results from the scanning electron microscopy (SEM/EDAX) show that there is a homogeneous distribution of barium and lime throughout the mass of the mortars (fig. 7) (fig. 8).

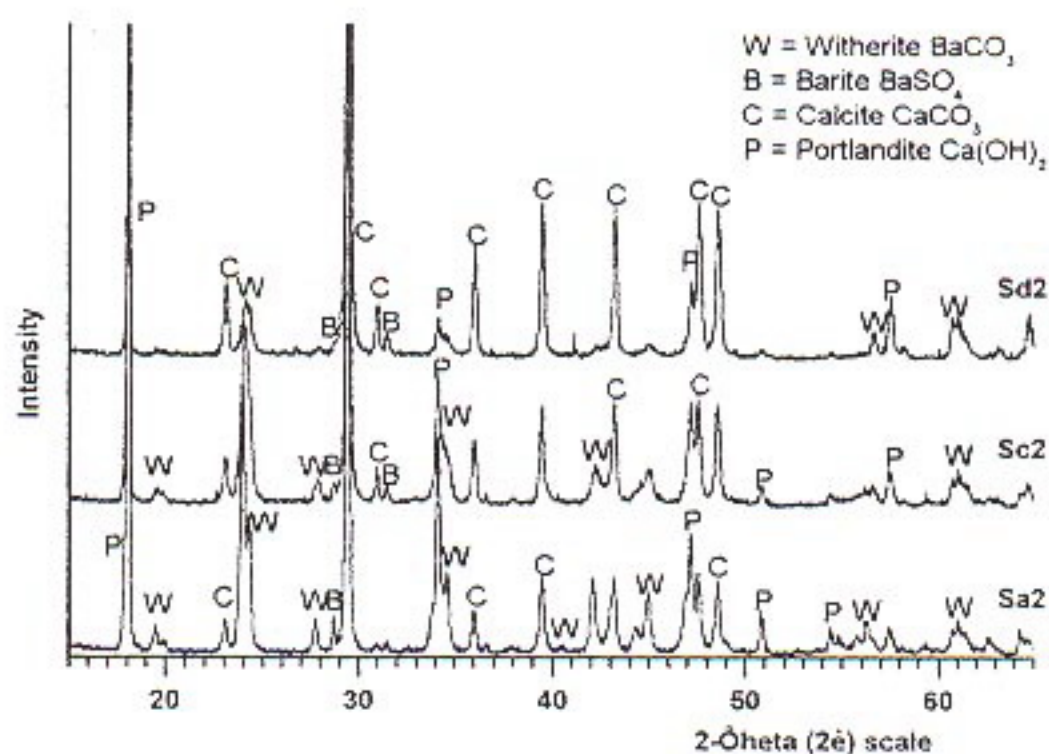
Figure 9: X-ray Diffraction results from samples taken from the centre of the specimens, 35 days old.

The analytical methods of infrared spectroscopy and X-ray diffraction were used for the characterization of the mortars and especially for verifying the formation of the barium compounds, witherite (BaCO_3) and barite (BaSO_4), to the matrix of the mortars (fig. 9). The

samples for the analysis were taken from two different points of the specimens, one near the surface, 1cm from the surface, and the other from the centre of the specimen, 2,5cm from the surface.

The analysis showed that barium carbonate (BaCO_3) is formed in both cases. This is very encouraging because it shows that the added barium hydroxide reacts with the calcareous material of the mortar, forming stable compounds.
