# 1<sup>ST</sup> INTERNATIONAL CONFERENCE

# Conservation Study of Traditional Glass - Panels from Siatista, Macedonia - Greece

V. Lampropoulos, I. Karatasios and E. Papaioannou

*T.E.I. of Athens, Department of Conservation of Antiquities and Works of Art, Greece*

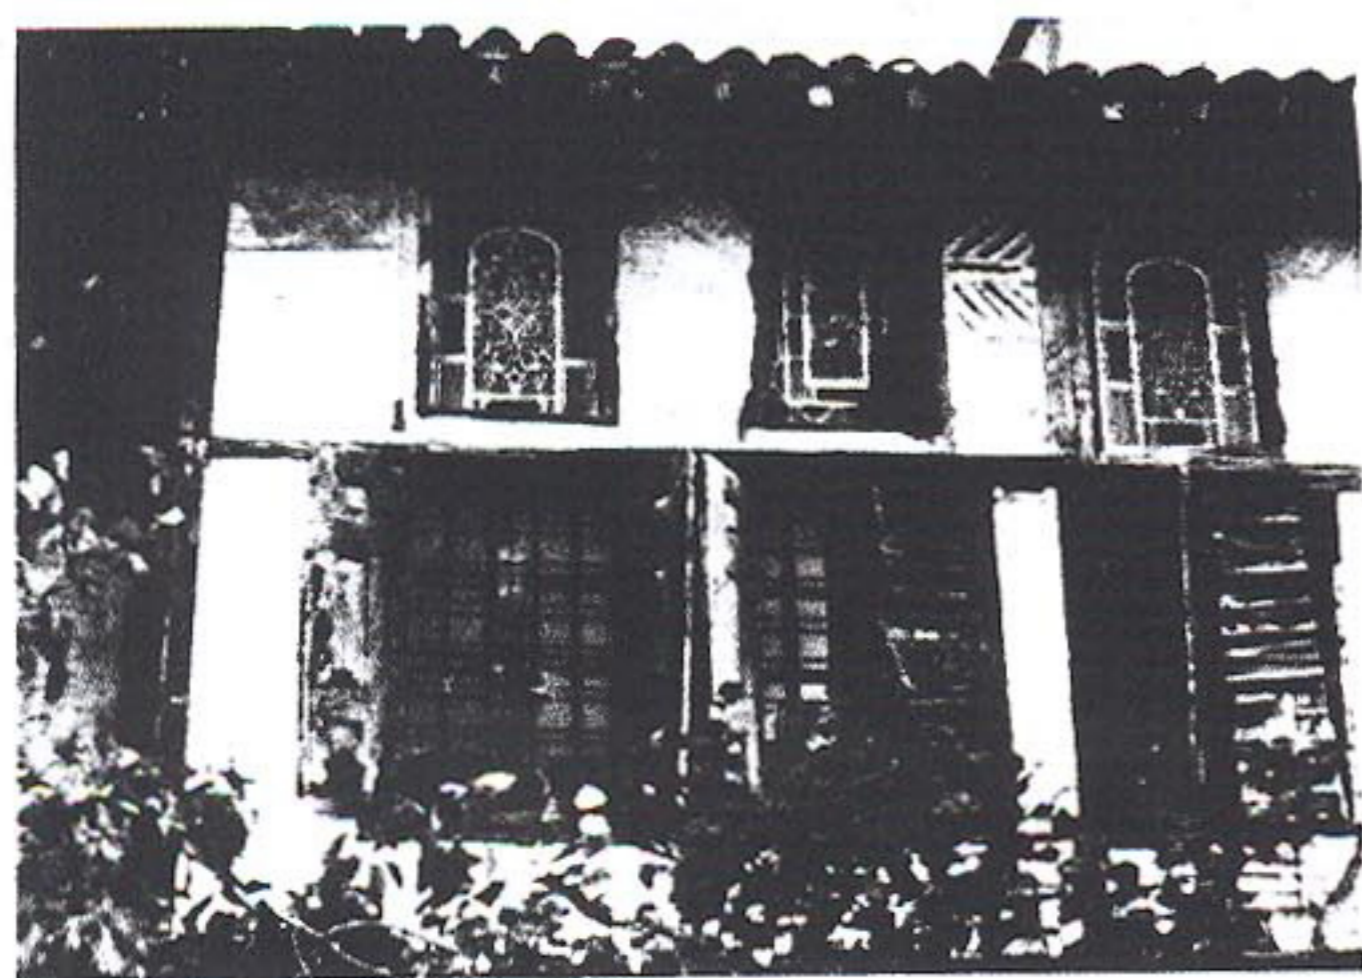
The village of Siatista, West Macedonia, Greece, was founded at the beginning of the 15th century. Between 1740 and 1780 a number of remarkable mansions were built. The ground floor windows were very small for security, while the first and second floor windows were decorated with colourful glass-panels (Fig. 1.) [1].

Fig. 1. A Siatista mansion decorated with traditional colourful glass windows (Macedonian Skylights).

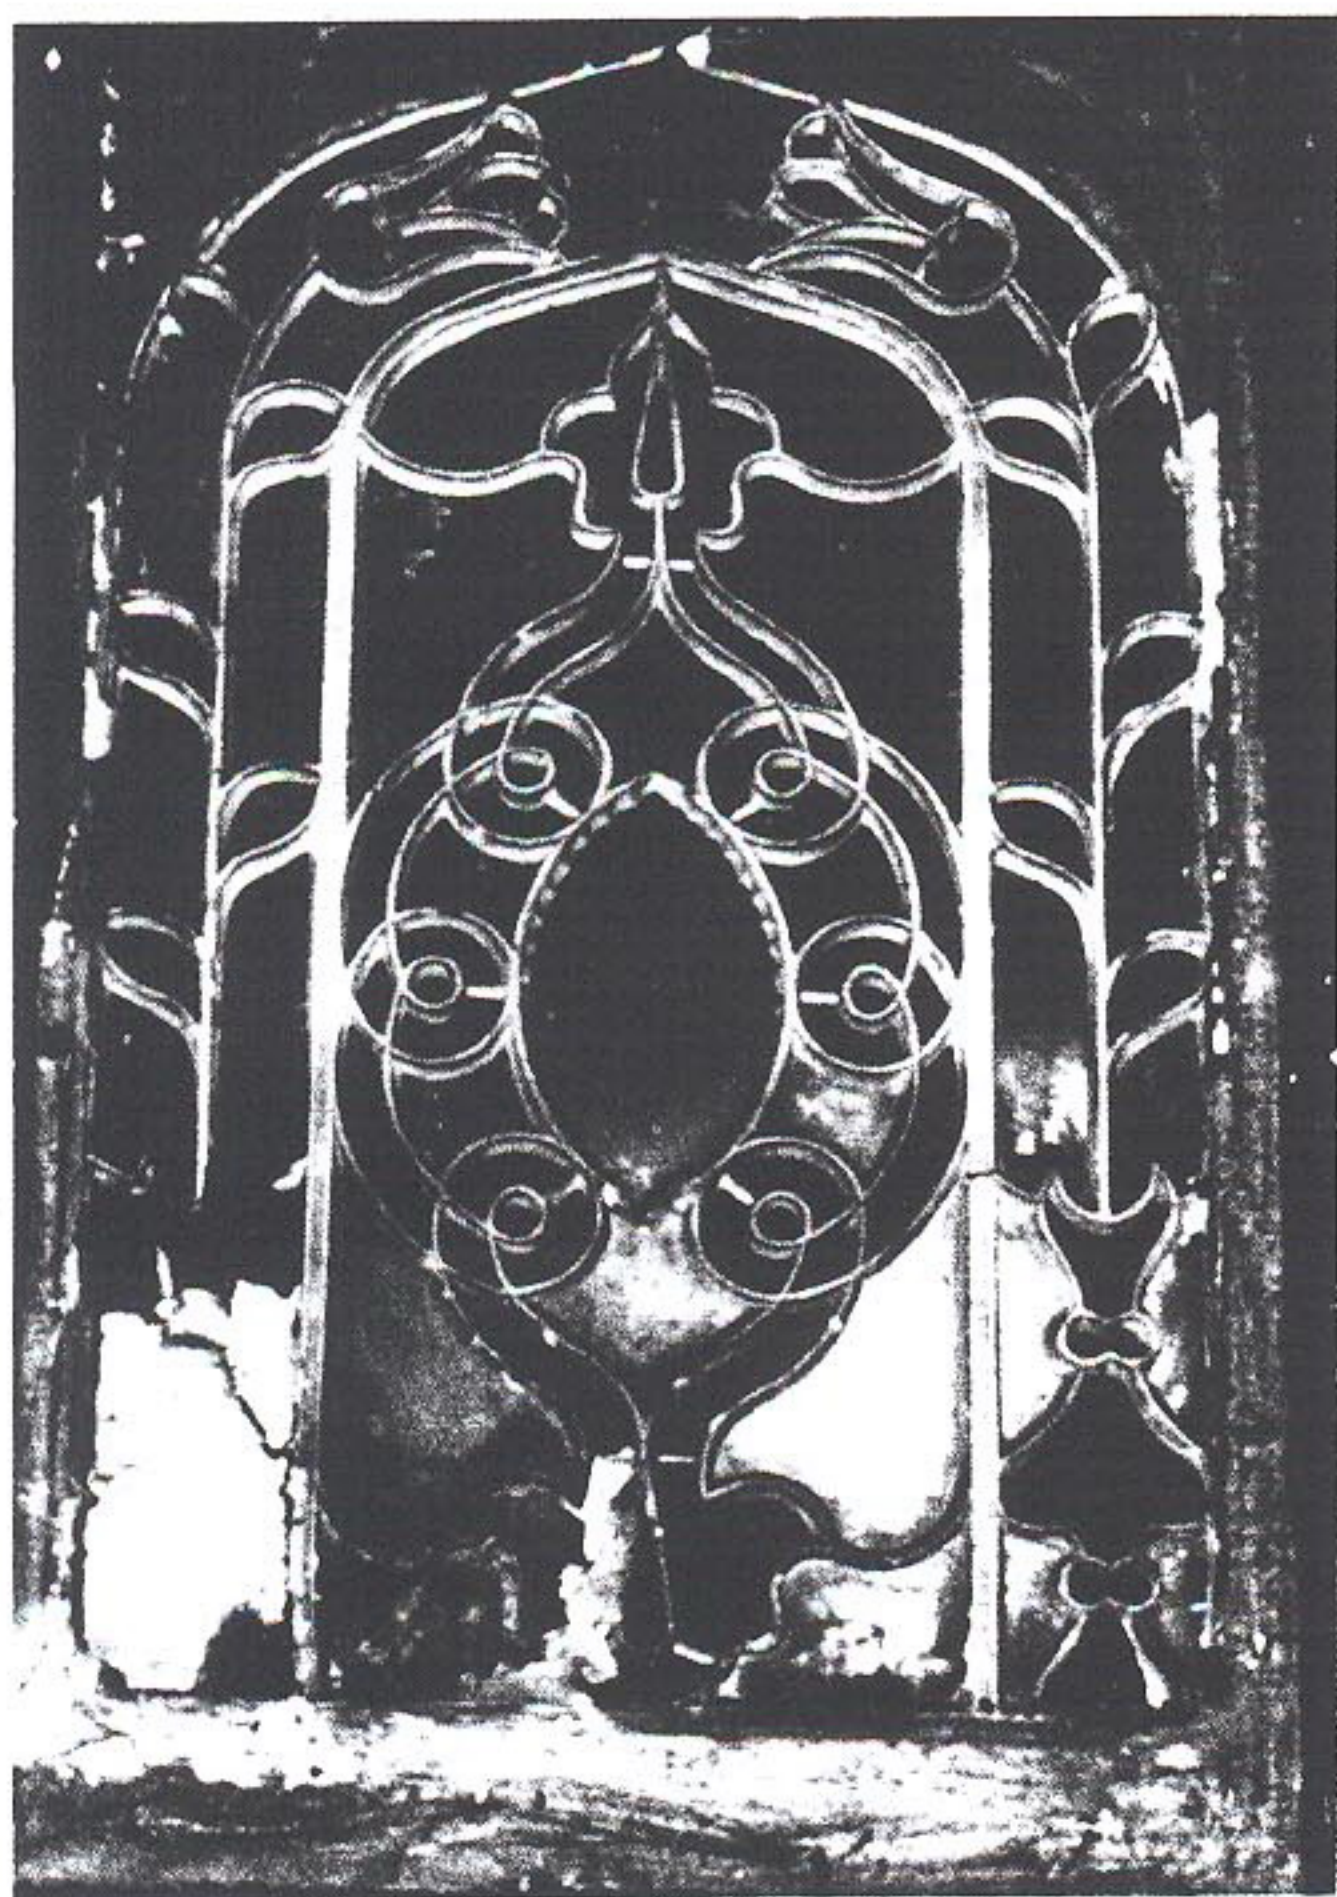
In the past, lost parts of glass panels have been filled with lime plaster, bricks and wood. In some other cases, decayed parts of the original gypsum grid have been replaced with new plaster and destroyed glass pieces have also been replaced with new ones (Fig. 2.).

Fig. 2. Detail of weathered glass window.
