# **Durability of Building Materials and Components 11**

## **Globality and Locality in Durability**

Proceedings CD of the Eleventh International Conference  
on Durability of Building Materials and Components, 11dbmc

Istanbul, Turkey  
11-14 May 2008

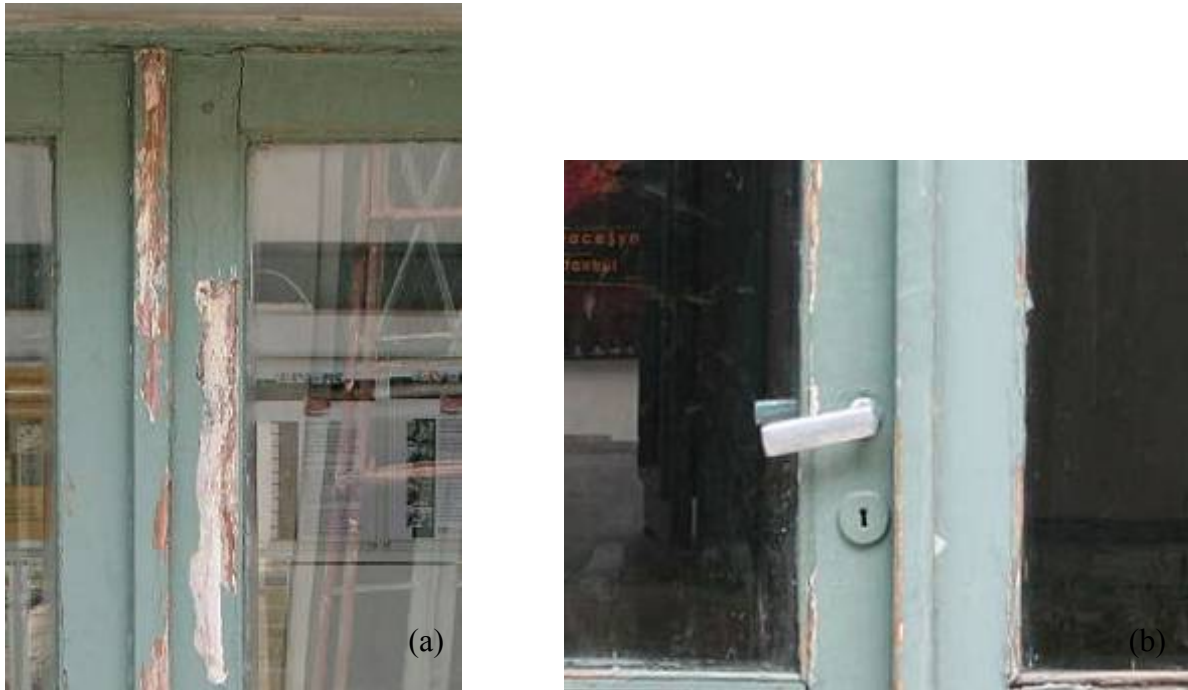
**Figure 3.** (a) Damage on the surface of wooden components of doors.  
(b) Deformation of door handle.

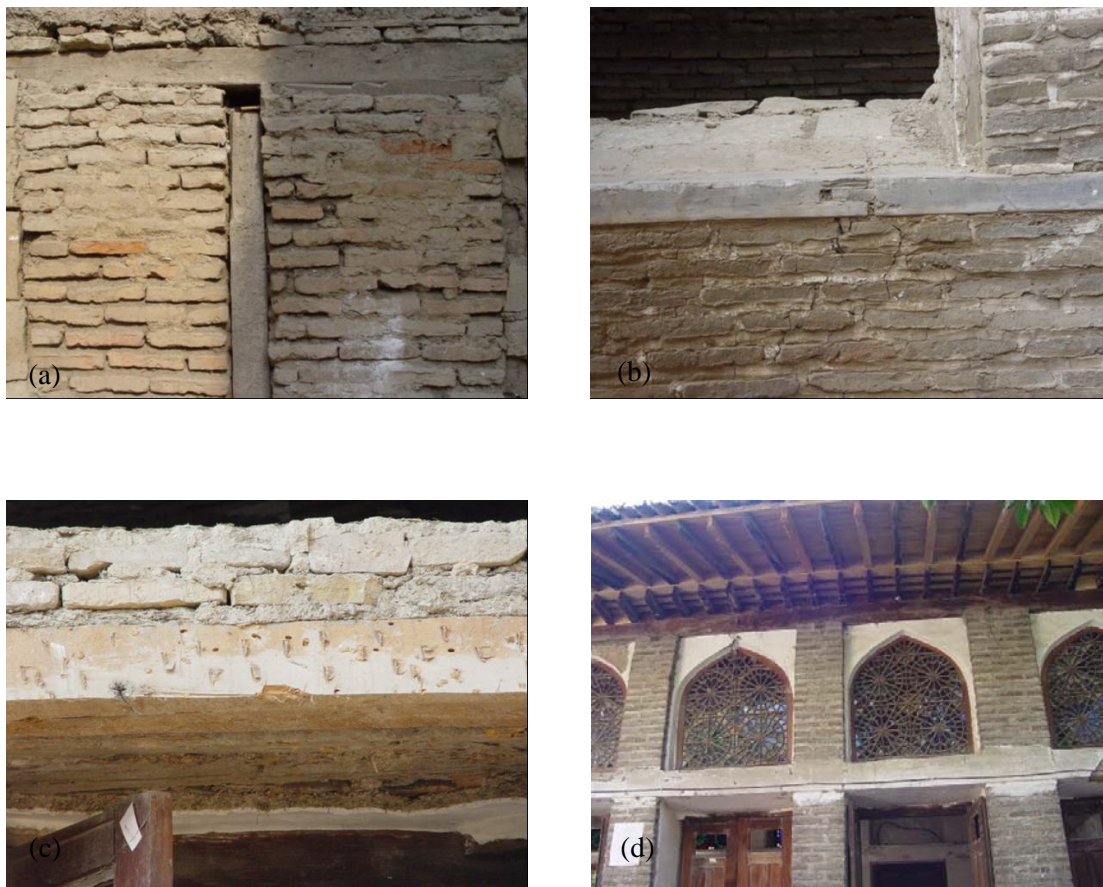
**Figure 3.** The main construction materials used in House of Bagheri, (a) brick and cob, (b) solid wood beneath the door, (c) solid wood up the door and (d) solid wood as main beam and rafters.

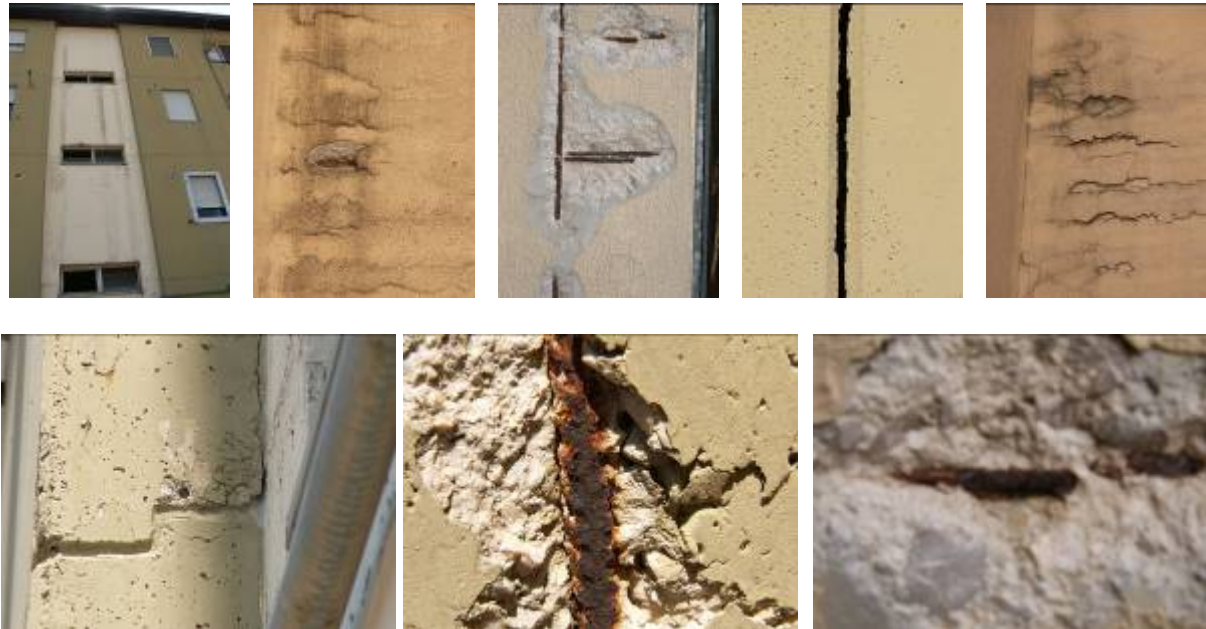
**Figure 6.** Expulsion of the layer protecting the steel road on the façade panels.  
Swelling and cracking of the plastic plaster
